**WASTEWATER CHARACTERIZATION AND
HAZARDOUS WASTE SURVEY, HICKAM AFB HI**

May 1987

Final Report

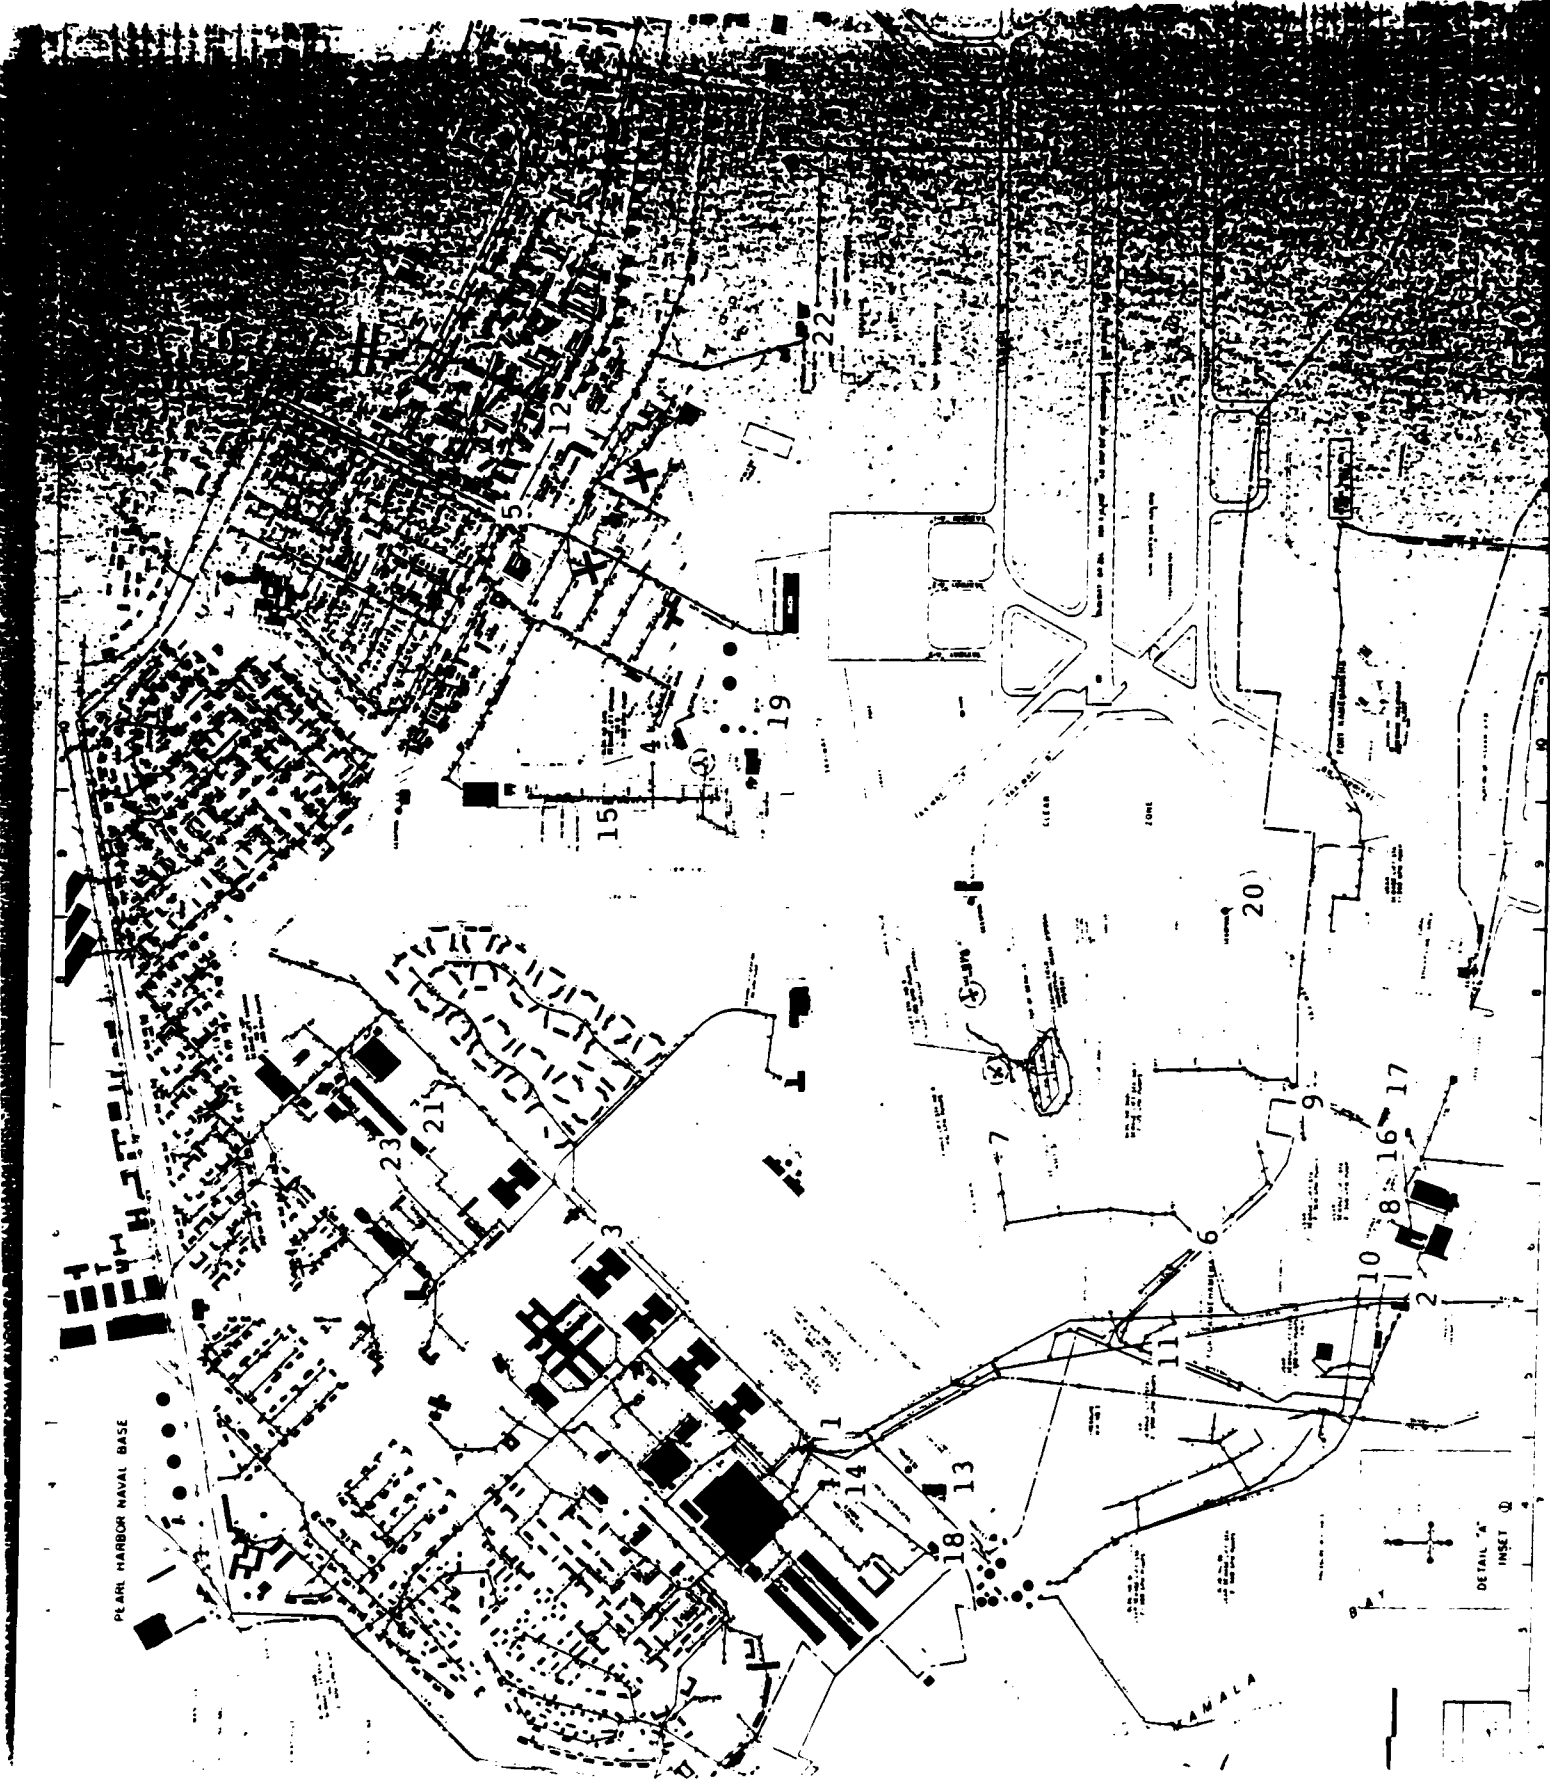
Figure 1. Site Locations

13	Bldg 3004 Refueling Hangar
14	Bldg 2016 Aircraft Washrack and Motor Pool
15	Bldg T-2130 Ref. Maint. washrack
16	Bldg T- 3428 Hangar washrack
17	Bldg 3429 Hangar, motor pool
18	Bldg 2010 Refueling maint.
19	Bldg 2153 Fuels (not sampled-empty)
20	Bldg 11665 Test cell
21	Bldg 2074 BX Gas Station
22	Bldg 4002 Auto Hobby Shop
23	Bldg 1263 C.E. Paint Shop

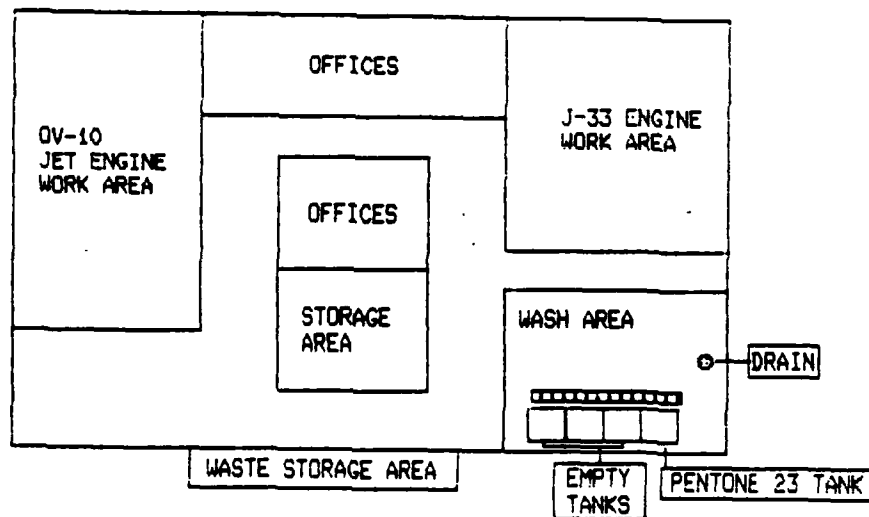
Figure 2. 15 CAMS Propulsion Shop Layout

The 15 CAMS Propulsion shop personnel repair, tear down and inspect T-76 and J-33 engines. The shop has three main sections (Figure 2): the T-76 shop, the J-33 shop, and the washrack. The only wastes generated in the two engine shops are waste oils.

The washrack area has 4 vats, but only one is used and it contains Penetone 23 (a cold stripper). The Penetone 23 has never been changed out, there is a water layer on top to prevent the Penetone from evaporating. Simple Green soap is used to clean engine parts at the washrack. The rinse water from this operation is discharged to the sewer.

A waste storage area is located outside this building for recyclable waste oil, contaminated waste oil, and halogenated waste products. A work order is pending to dike this storage area.

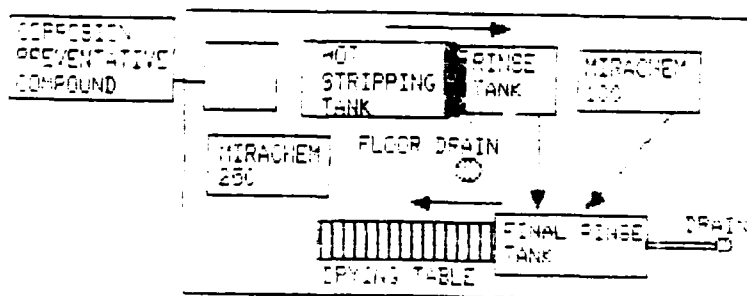
Figure 6. 15 CAMS Wheel and Tire Shop Washroom Layout

The wash room is comprised of 7 tanks (Figure 6). One tank contains Mirachem 250 (acid), used to clean stainless steel wheel heat shields. According to shop personnel this tank has only been emptied once when the acid was neutralized and drained to the sewer system. Located next to this tank is a tank containing corrosive preventative compound (CPC). This tank has never been drained. A series of 5 tanks are used to strip paint from wheels. Two tanks contain a hot and a cold stripper. A wheel is placed in one of the stripping tanks, rinsed twice in different rinse tanks, then finally placed on the drying table. Wheels not needing stripping are washed in a tank containing Mirachem 100 (soap, NSN 6850-PNIS-G-8074) then transferred to the final rinse tank and placed on the drying table.

Spent solvent from the two stripping tanks is disposed of by pumping into 55-gallon drums and removed as hazardous waste through DRMO. When the two rinse tanks and the tank with Mirachem 100 needs to be changed, their contents are drained to the sewer system. Empty paint spray cans are punctured and thrown in the trash. Waste hydraulic fluid used in aircraft jacks is stored in 55-gallon drums and disposed of through DRMO.

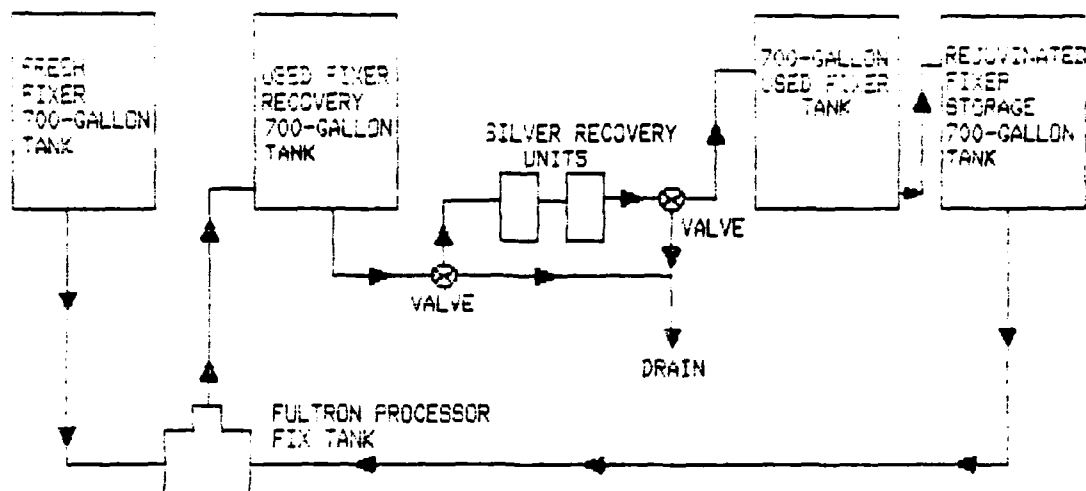
Figure 7. 548 RTG Fixer System

The 548 RTG Shop personnel are responsible for mixing and analysis of all black and white processing chemicals used within the division. The chemicals are mixed in vats that gravity feed to other shops in the building. All photo wastes (approximately 1249 gallons/month before dilution) are disposed of into the sewer. The photo fixer is used on a closed system (Figure 7) most of the time. The system is opened when the fixer is no longer effective, at which time the fixer is sent through an automatic silver recovery unit prior to discharging to the sewer. The silver recovery system is suppose to be 98% efficient.

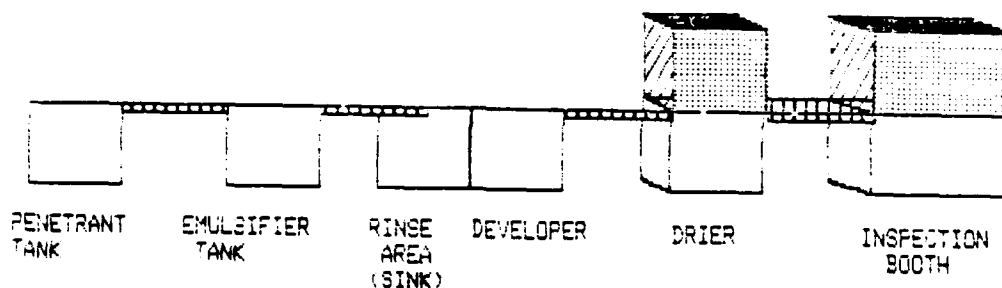
Figure 8. NDI Penetrant Inspection Process

The penetrant inspection (Figure 8) is an open system which uses a penetrant, emulsifier, and developer. Parts are dipped into the penetrant; removed; placed in the emulsifier; rinsed; and allowed to drip dry. The part is then placed in a developer and passed through an oven and dried. It is finally inspected and rinsed. The photo lab in the NDI shop uses fixers and developers in the developing process. The rinse water and chemicals from the process is put through two silver recovery processes before being discharged.

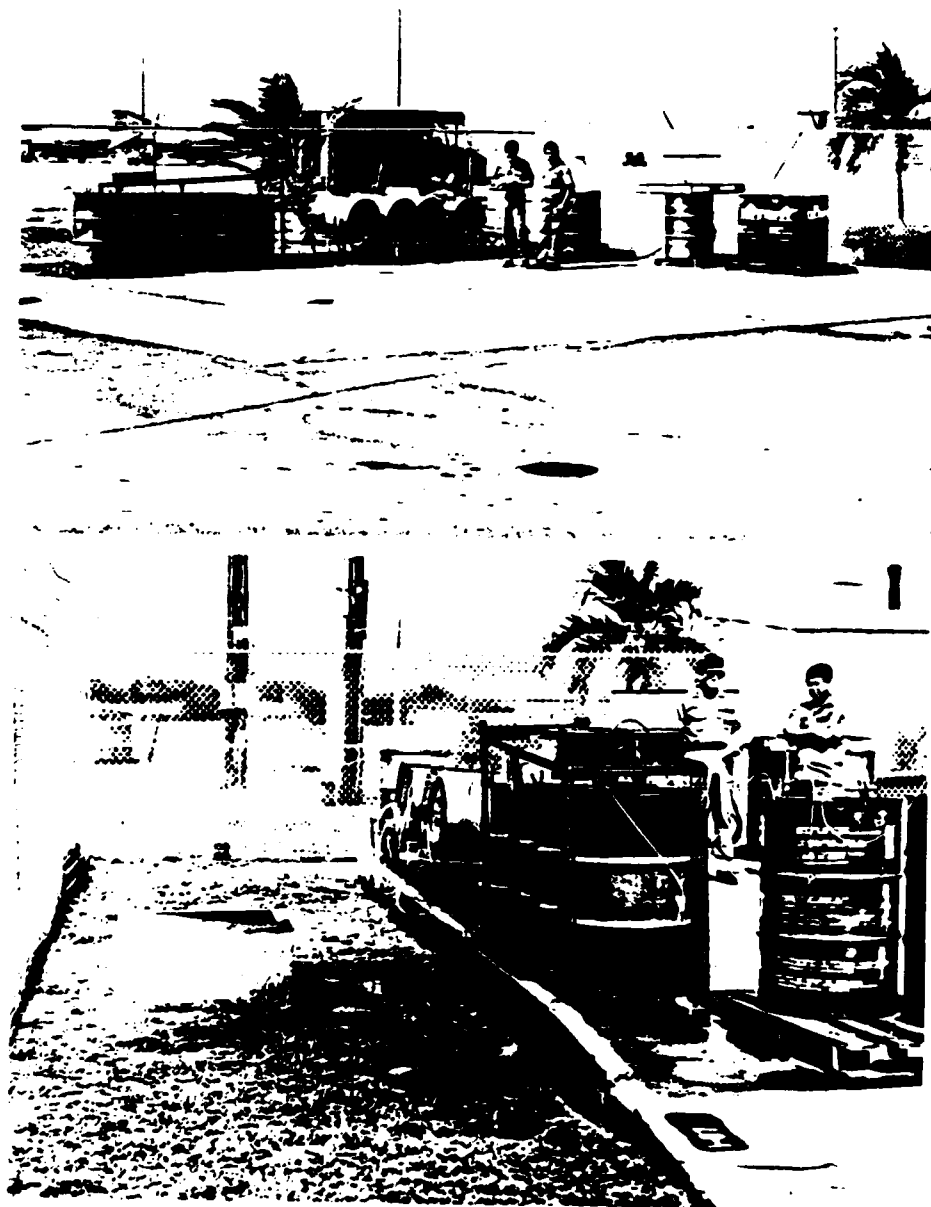
Figure 9. HANG AGE Washrack and Storage Area

The hazardous waste storage area for HANG AGE is located on the HANG AGE washrack (Figure 9). This storage area is not curbed, secured, or covered. During our visit we observed shop personnel cleaning the area with soap and water with the rinsewater going to an oil/water separator located adjacent to the washrack. The soaps used in this area to clean AGE equipment may emulsify the oil and any wastes collected in the oil/water separator and this emulsified liquid are capable of passing untreated through the separator to the sewage treatment plant.

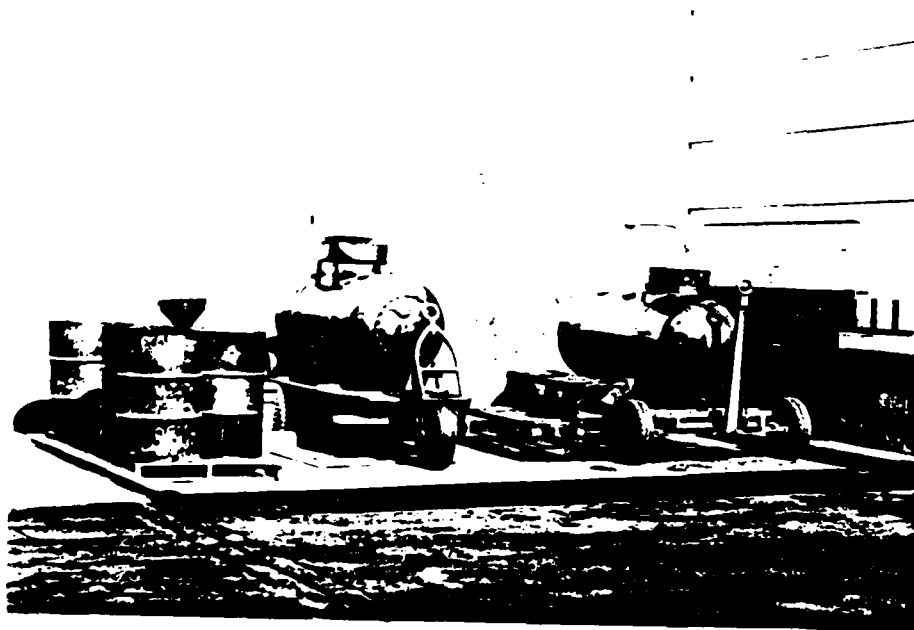
Figure 10. 15 CAMS AGE Storage Area

The 15 CAMS AGE waste oil storage area is located next to building 2030 (Figure 10). This site is curbed, but not secured or covered. Also, a drain is located inside the curbing. During our visit we noticed an airman cleaning a tank where oil had spilled by pouring a bucket of PD-680 over the tank to clean it and then rinsing the PD-680 and oil down the drain. The shop supervisor saw this and immediately informed the airman of the proper procedure (use a rag to wipe the outside of the tank rather than pouring PD-680 over the tank).

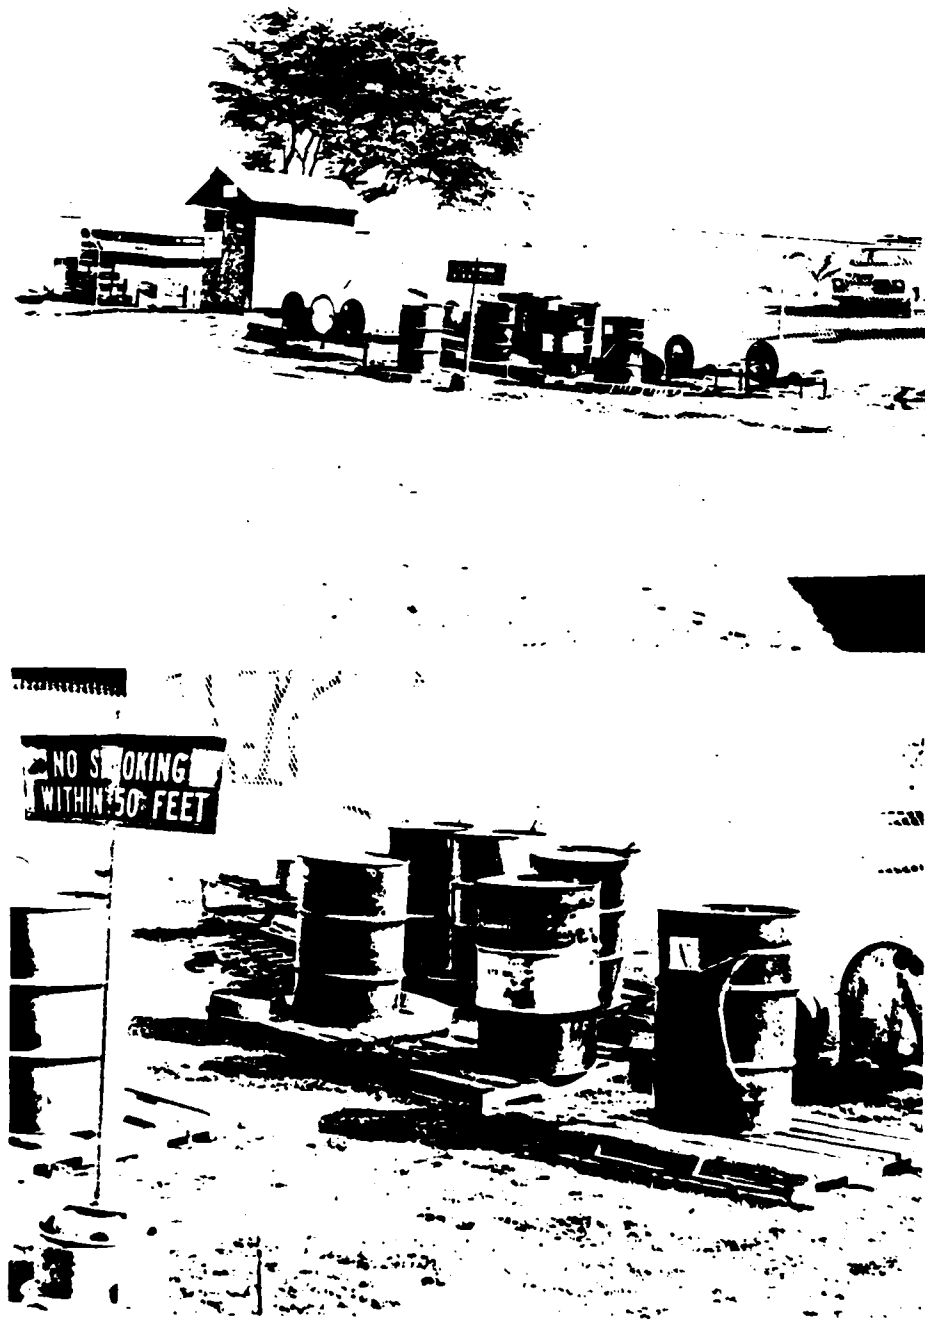
Figure 11. HANG Motor Pool Storage Area

There are three accumulation sites on base and none are permitted because waste are removed from these sites within 90 days. Most accumulation sites, i.e., HANG Motor Pool Storage area, are not curbed, covered and secured (Figure 11), however plans are under way to upgrade these sites.
